Contract #: 04-0120F4Cty: SF/ALA Rte: 80 PM: 13.2/13.9File #: 69.28**WELDING INSPECTION REPORT****Resident Engineer:**Siegenthaler, Peter**Address:** 333 Burma Road**City:** Oakland, CA 94607**Report No:** WIR-017984**Date Inspected:** 06-Nov-2010**Project Name:** SAS Superstructure**OSM Arrival Time:** 700**Prime Contractor:** American Bridge/Fluor Enterprises, a JV**OSM Departure Time:** 1900**Contractor:** Zhenhua Port Machinery Company, Ltd (ZPMC), Changxing Island **Location:** Shanghai, China**CWI Name:** Li Yang**CWI Present:** Yes No**Inspected CWI report:** Yes No N/A**Rod Oven in Use:** Yes No N/A**Electrode to specification:** Yes No N/A**Weld Procedures Followed:** Yes No N/A**Qualified Welders:** Yes No N/A**Verified Joint Fit-up:** Yes No N/A**Approved Drawings:** Yes No N/A**Approved WPS:** Yes No N/A**Delayed / Cancelled:** Yes No N/A**Bridge No:** 34-0006**Component:** OBG Segment**Summary of Items Observed:**

ZPMC SHIP # 19 (10AW)

ZPMC SHIP # 19 (10BW)

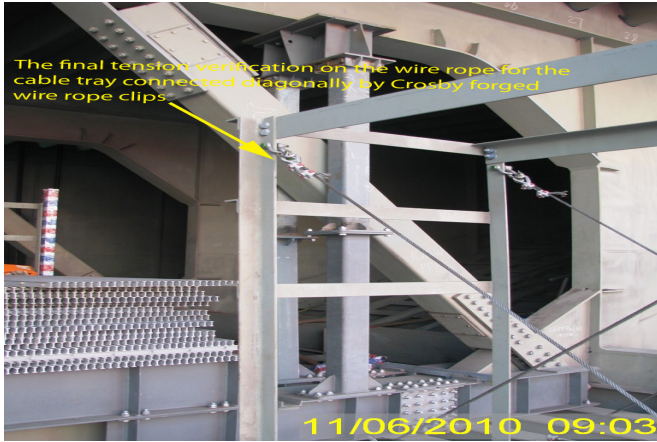
This QA Inspector witnessed the final tension verification on the wire rope for the cable tray connected diagonally by Crosby forged wire rope clips. The QA inspector observed the tensioning of the wire rope appeared to be in general compliance with the Request for Information (RFI) No. ABF-RFI-001874R00 dated. August 27, 2009. The segment and panel point designations were as follows:

10AW – PP 85.5-PP 86 and PP 87-PP 88
10BW – PP 89-PP 90 and PP 90-PP 91
10CW – PP 91.5-PP 92 and PP 92-PP 93
